# **NOAA Marine and Aviation Operations Marine Operations Center-Pacific Pier Fire Incident**

**October 6, 2006**

**U.S. DEPARTMENT OF COMMERCE  
National Oceanic and Atmospheric Administration  
Office of the Chief Administrative Officer  
Safety and Environmental Compliance Office**

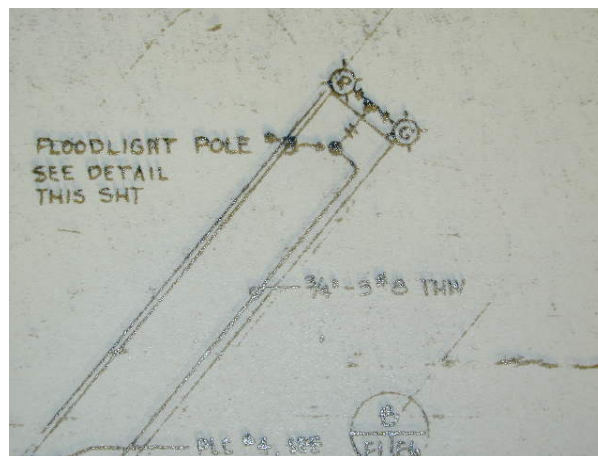
Fig. 1

There was a 277 volt electrical service wire inside a 3/4" electrical conduit mounted underneath the pier deck running from the Maintenance Shop to an electrical box on the light pole standard. At this electrical box the power then branches to: 1) the main light on the pole located at the end of the Pier A, and 2) to a fuse box before proceeding to a step-down transformer which brought the voltage down to 120 volts and then branching again to two navigational lights on the end of Pier A. This 277 volt circuit was servicing a light standard (Fig. 1) and two navigational lights (Fig. 2) at the end of the pier, as well as several light standards around the Maintenance Shop and Pier A area.

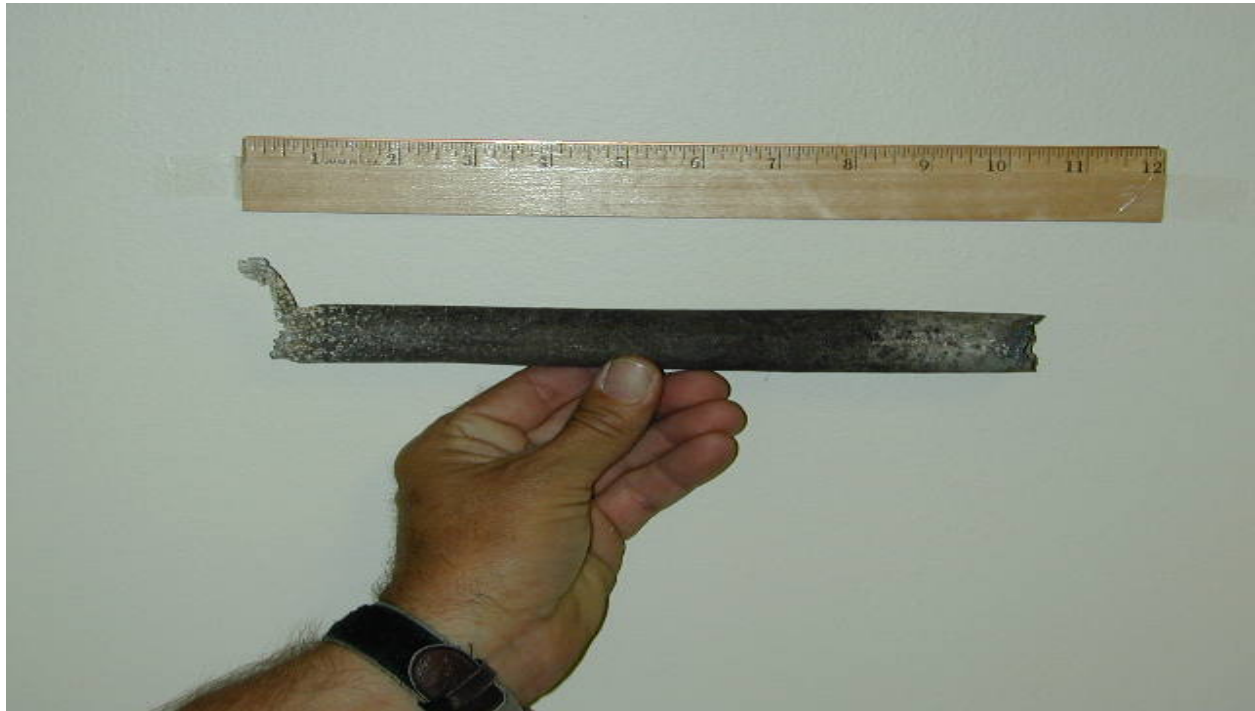
Fig. 3

Pieces of the conduit located further down the line towards the direction of the Maintenance Shop were pitted with holes going all the way through the conduit walls (Fig. 3).

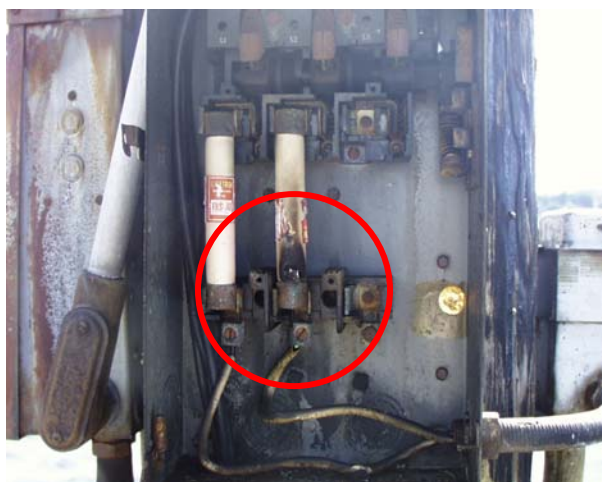
Fig. 4

The fuse between the 277 volt power system and the right pier navigational light appeared to have slowly burned out (Fig. 4). This fuse was examined closely after removal from the fuse box (Fig. 5).

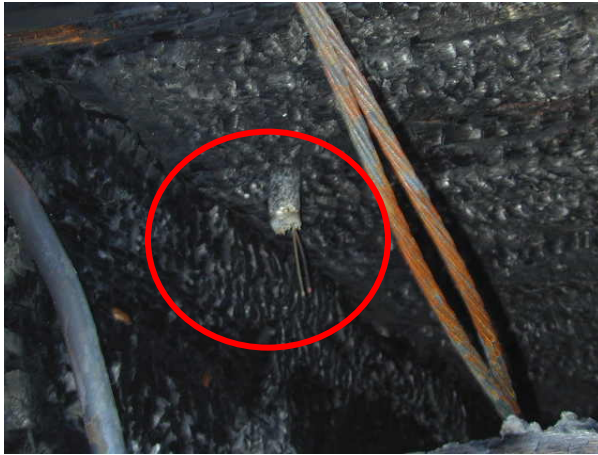
Fig. 6

The copper wiring directly below the right navigational light displayed uniform copper beads, (Fig. 6), indicating an electrical short had occurred at that point in the wires. A close up picture of the melted copper ends is depicted in Fig. 7.

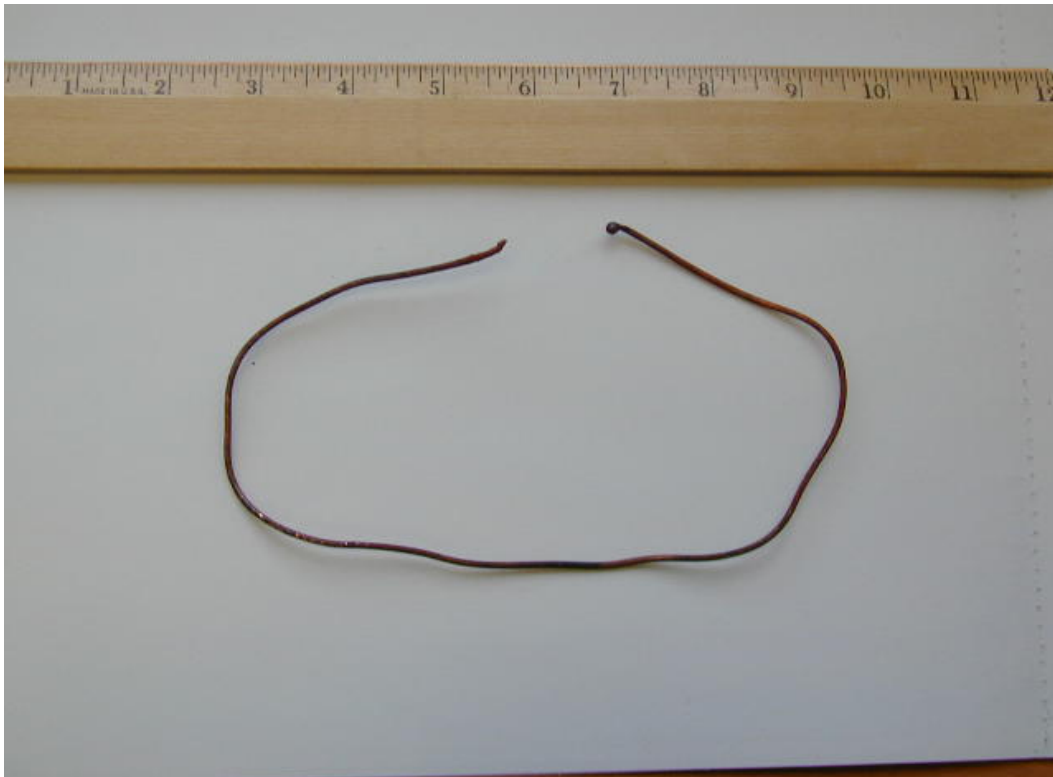
Fig. 8

This piece of wire (Fig. 8) with uniform beads of melted copper on each end, typical of arced wire, was collected from the charred utility platform directly below the right navigational light.

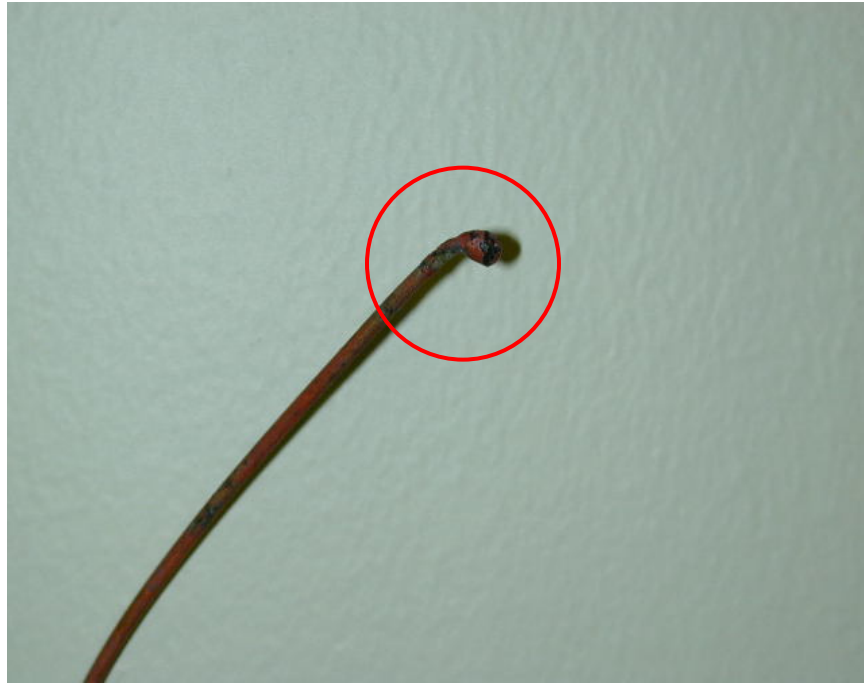
Fig. 9

A close up of the wire strand with the melted insulator inside the melted copper center is indicative of an electrical arc within the copper wire caused by a short circuit between the wire and the metal conduit (Fig. 9). As indicated above, this wire was collected from the utility platform (Fig. 10) located directly below the right navigational light.

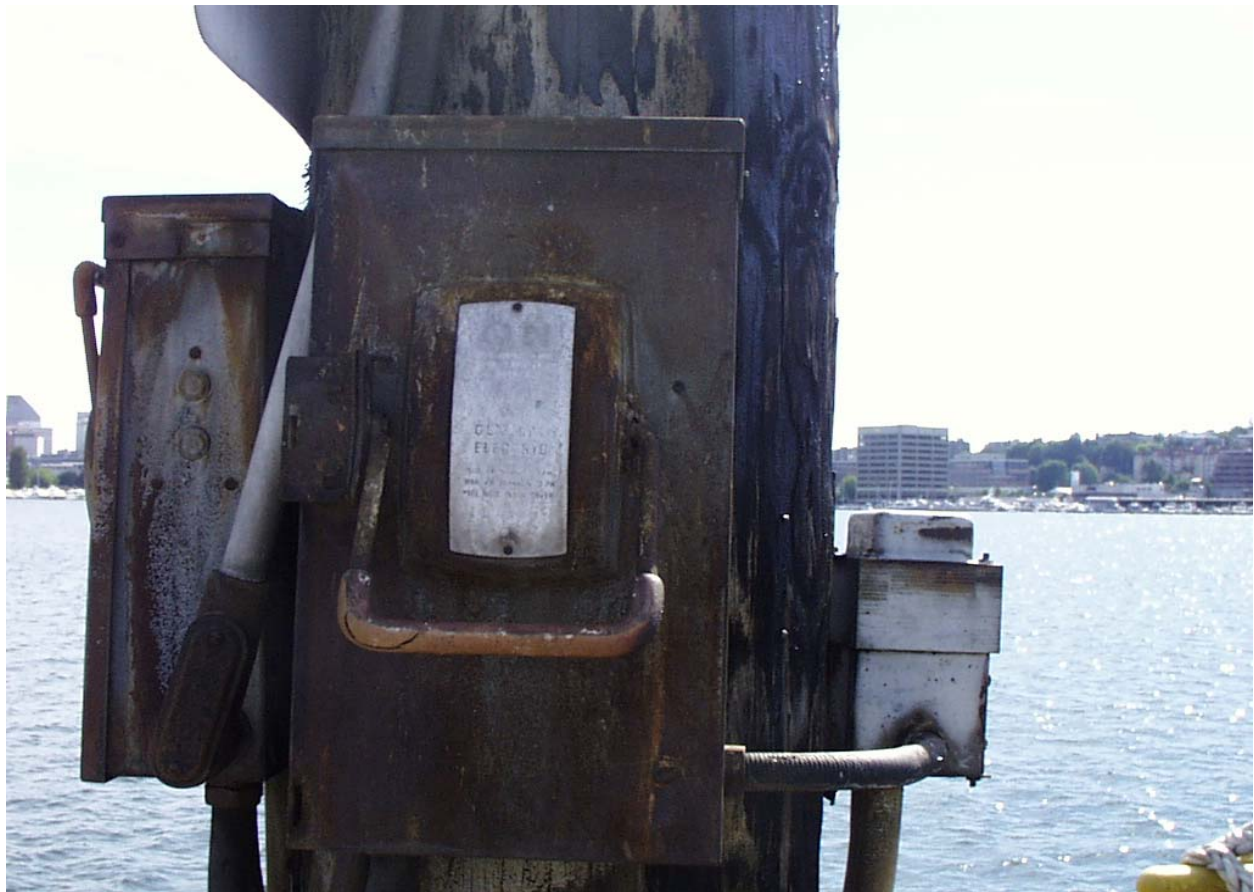
Fig. 11

The disconnect switch on the light standard showed signs of corrosion and oxidation and was reported by the facility manager as the original wiring installed in 1963 (Fig. 11).

1. The deterioration of the wiring and the switch panel supplying power to the right navigational light located on the end of Pier A caused an electrical fault in the wiring between the fuse box on the light pole and the right navigational light. This electrical fault generated sparks and molten metal that subsequently fell on the dry timbers of the platform below the main pier deck. This sheltered location was the point of ignition for this fire.

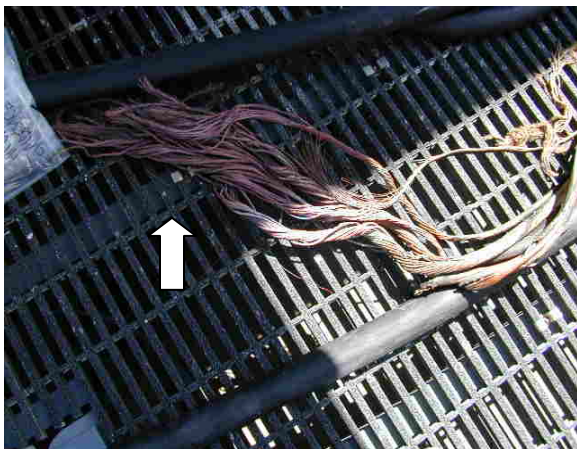
Fig. 12

The shore power cable servicing the ASSERTIVE was pulled apart at the center section when the tugboat pulled the ship away from its pier mooring location at approximately 05:37 on July 5, 2006. One section of the ship-to-shore power cable remained on the ship (Fig. 12), the other section of the cable on the pier deck (Fig. 13). The shore power cable insulation was burned off the copper conductors (wire strands) but the frayed conductor ends showed no signs of arcing or electrical overheating.

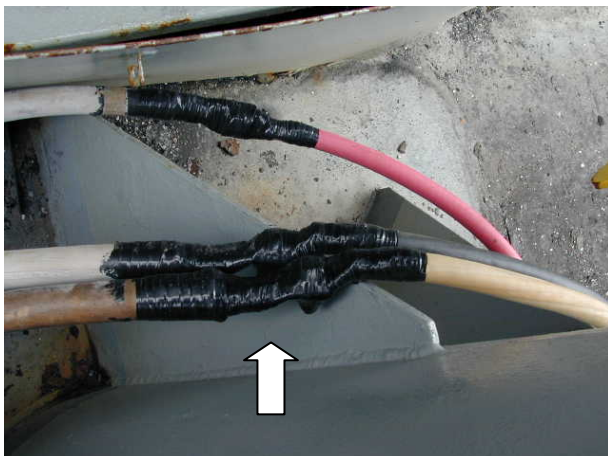
Fig. 14

The shore power cable was spliced at approximately 10-15 feet from the ship side plug. These were crimped lugs bolted together and wrapped in electrical tape (Fig. 14 and 15). The splices showed no signs of damage or overheating.

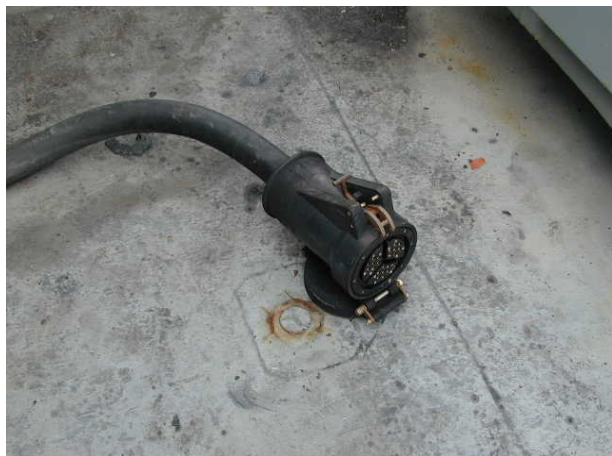
Fig. 16

The shore power cable end plug and ship's receptacle (Fig. 16 and 17) showed no signs of damage, arcing or overheating.

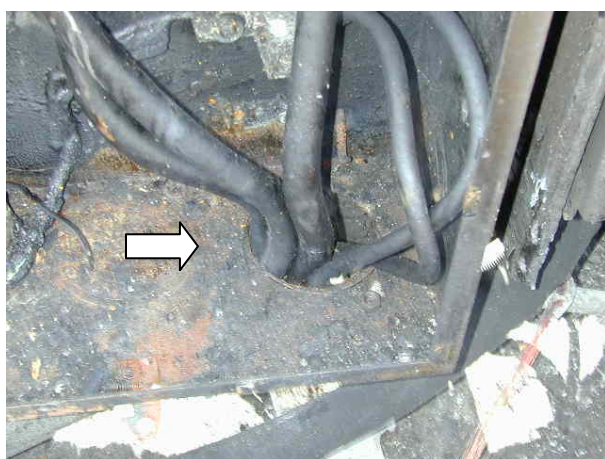
Fig. 18

The shore power cable that remained on the pier was draped through a knock out hole (Fig. 18) and was hardwired to the lugs on the electrical panel (Fig. 19). The lug connections showed no signs of damage, arcing or overheating.

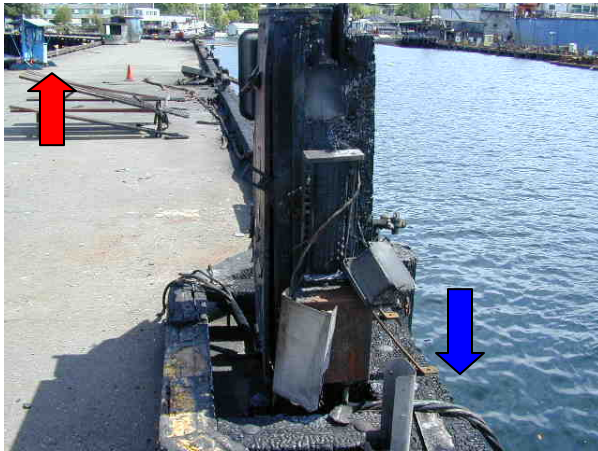
Fig. 20

There was a multiple receptacle electrical power station (Fig. 20 red arrow) located on the Pier A deck with its power supply cable draped underneath the pier. The cable came up from underneath the pier next to the electrical panel (Fig. 20 blue arrow), but the cable leads were not connected to the electrical panel. The leads were insulated (with electrical tape) and moved to the side (Fig. 21). The facility manager reported that these leads were moved to allow room for the ASSERTIVE shore power cable hook-up several months before the fire. This cable was not energized at the time of the fire. Although the cable was not energized, the use of flexible wire for fixed wiring purposes is precluded by Code of Federal Regulation, Title 29 Part 1910.(g)(1).

2. The ship-to-shore power cable to the ASSERTIVE did not malfunction, cause, or contribute to this fire.
3. The auxiliary (multiple receptacle) ship-to-shore power cable supply was not energized at the time of the fire, and therefore could not have caused nor contributed to this fire. Had this cable been energized, it would have been an inappropriate use of temporary flexible wiring to replace fixed wiring.

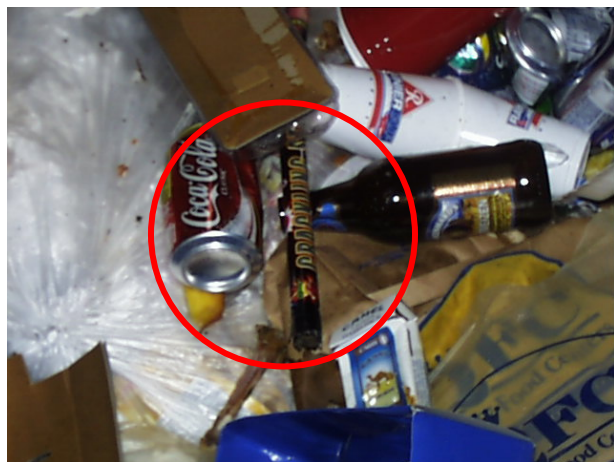
Fig. 22

The guard reported fireworks usage on Pier A to the facility manager at approximately 21:45 on July 4, 2006. Spent fireworks casings (Fig 22) were discovered by the investigators in the dumpster located on Pier A. (Fig. 23).

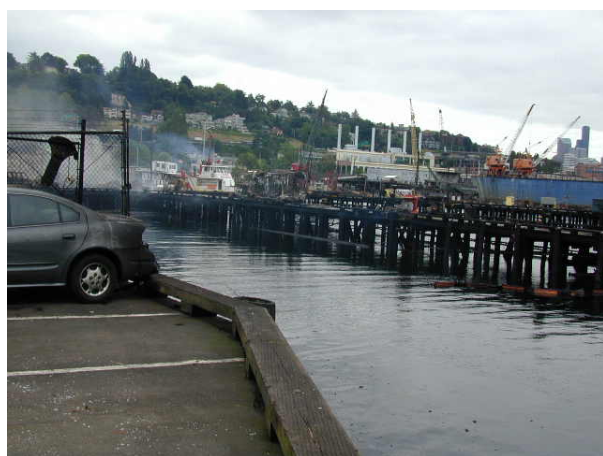
Fig. 22

The pier was constructed in 1963 and consisted of creosote wood pilings for protection from water immersion topped with a concrete and asphalt deck (Fig. 22). The pier was not equipped with a fire suppression system underneath the pilings, but it was constructed with draft stops located approximately every 100 feet to impede the spread of a fire (Fig. 23 and 24).

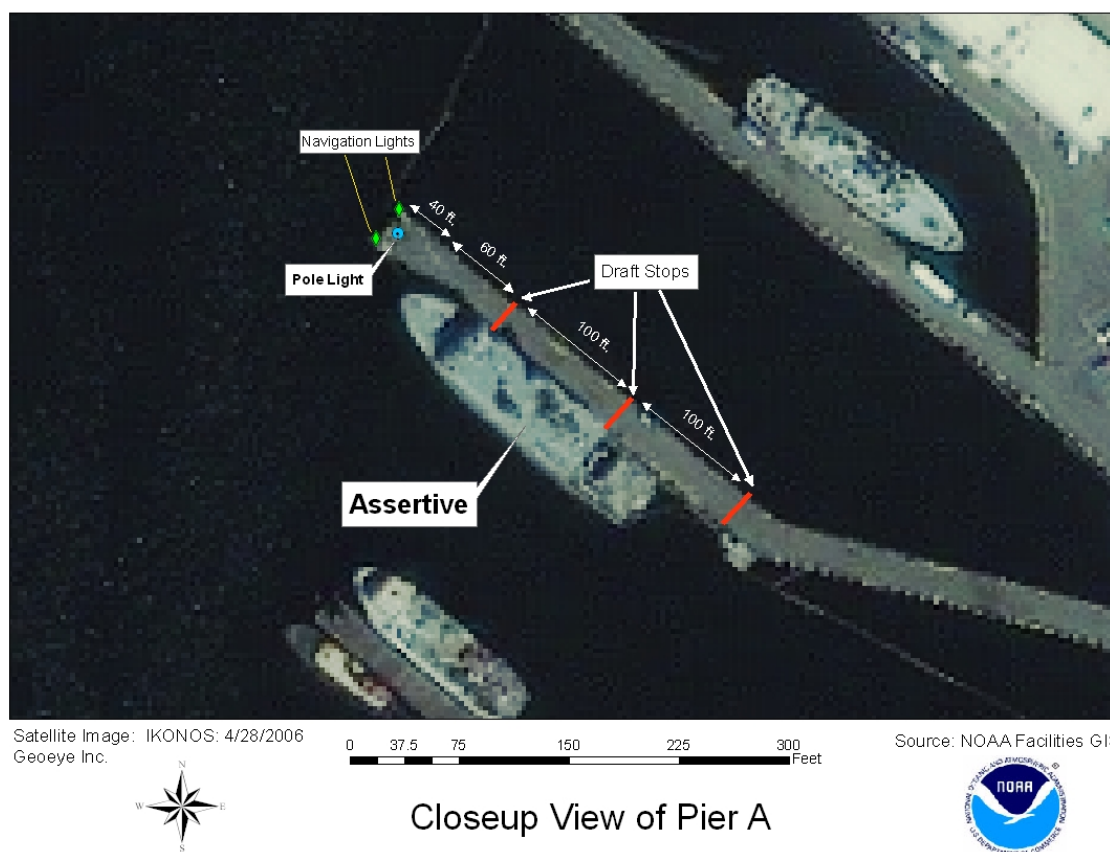
Fig. 24

The ASSERTIVE, a ship NOAA recently acquired from the United States Navy, was moored alongside Pier A when the fire erupted. Two distinctive burn marks are visible on the starboard side of the vessel (Fig. 25 and 26) with the first located approximately 60 feet back from the bow, and the other approximately 100 feet further down the starboard side from the first. The metallurgical evaluation of the ASSERTIVE, which was conducted by the MOC-P damage assessment team, indicated the hottest section of the two areas listed above was the marking located 60 feet from the bow of the vessel. The bow of the ASSERTIVE was 40 feet from the end of Pier A. The locations of these burn marks correspond to the draft stops on Pier A shown in Figure 24.

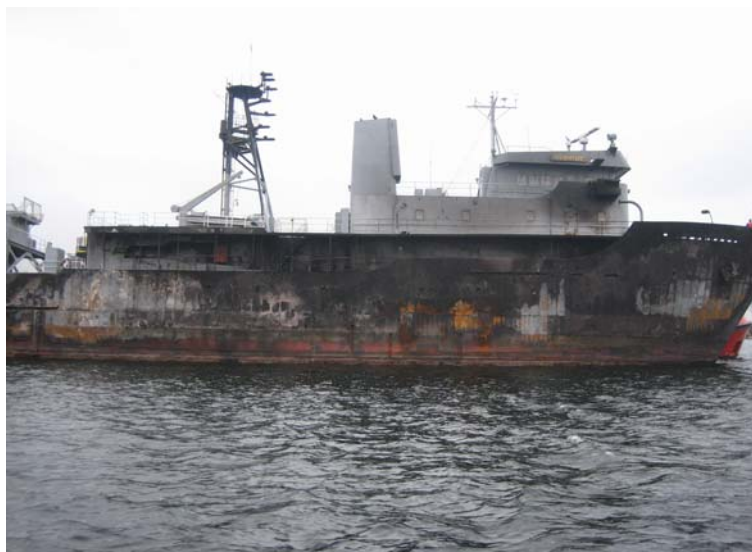
Fig. 25

7. The two burn marks alongside the ASSERTIVE, one approximately 60 feet from the bow and the other approximately 100 feet further down the starboard side, were caused as the pier draft stops delayed the progression of the fire until the fire burned deep enough to breach these wooden walls.
